## HAZARDOUS MATERIALS INCIDENT

### MAJOR INCIDENT REPORTING FORM

1. INCIDENT NAME: Davison County UPS HAZMAT Spill
2. PREPARED BY: Jeff Bathke PHONE: 605-999-2863 DATE: 6-14-2016 TIME: 2340
3. STATUS: Resolved
4. LOCATION AND DESCRIPTION

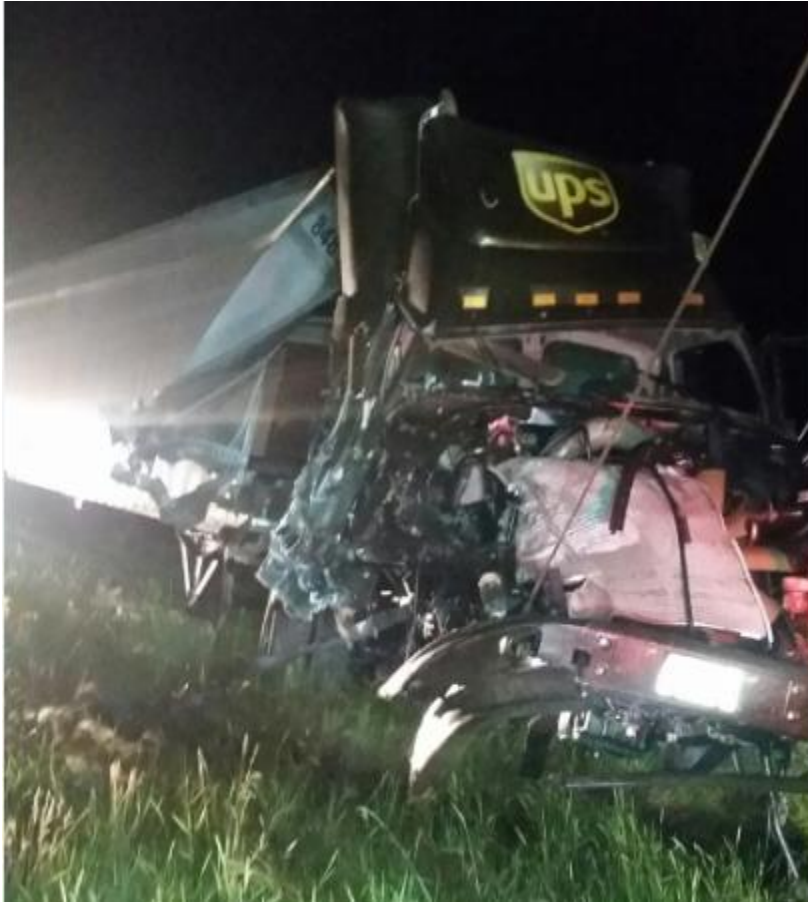
PHOTO #1

- b. DAMAGES: Severe damage to UPS truck (see photos), none to roadway.
  - c. SUMMARY: At 2340 on 14 JUN 2016 EM Bathke received a call from Deputy Sheriff Reitzel regarding a fuel spill in the east bound lane at MM 328 on I-90. A UPS transport truck rear ended another truck. An 80 gallon fuel tank was ripped from the passenger side of the UPS truck, spreading fuel on a 100-150 foot long stretch of the passing lane. Patrolman Peterson (SDHP) was the Incident Commander. EM Bathke called State Radio at 2343 and received a call back from Duty Officer Teresa Tople at 2348. DO Tople notified Kelsey Newling with DENR.  
At 0700 on 15 JUN 2016 the SD DOT applied a generous amount of floor dry on the Interstate, in an attempt to soak up the fuel. A portion of the fuel, as well as oil, was noticed in the median.  
At 0834 on 15 JUN 2016 Kim McIntosh from DENR called requesting information. She was going to call DOT and request the floor dry be captured and properly disposed of, if possible.

DESCRIPTION: UPS Truck

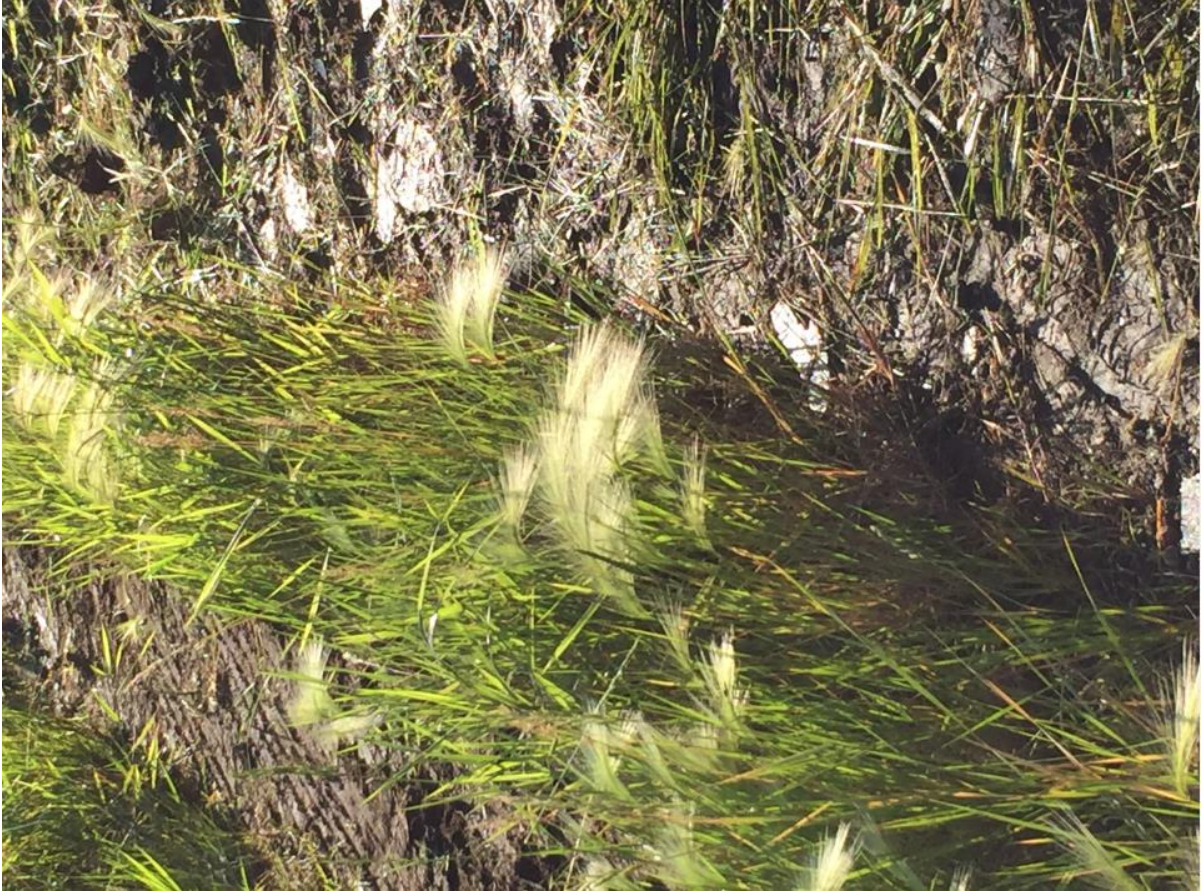
PHOTO #2

DESCRIPTION: Soil with oil/fuel

MOVEMENT: The spill was on I-90 and was completely contained to either the roadway or the median. The SD DOT applied floor dry on the road surface and UPS was putting a plan together to have the soil excavated.

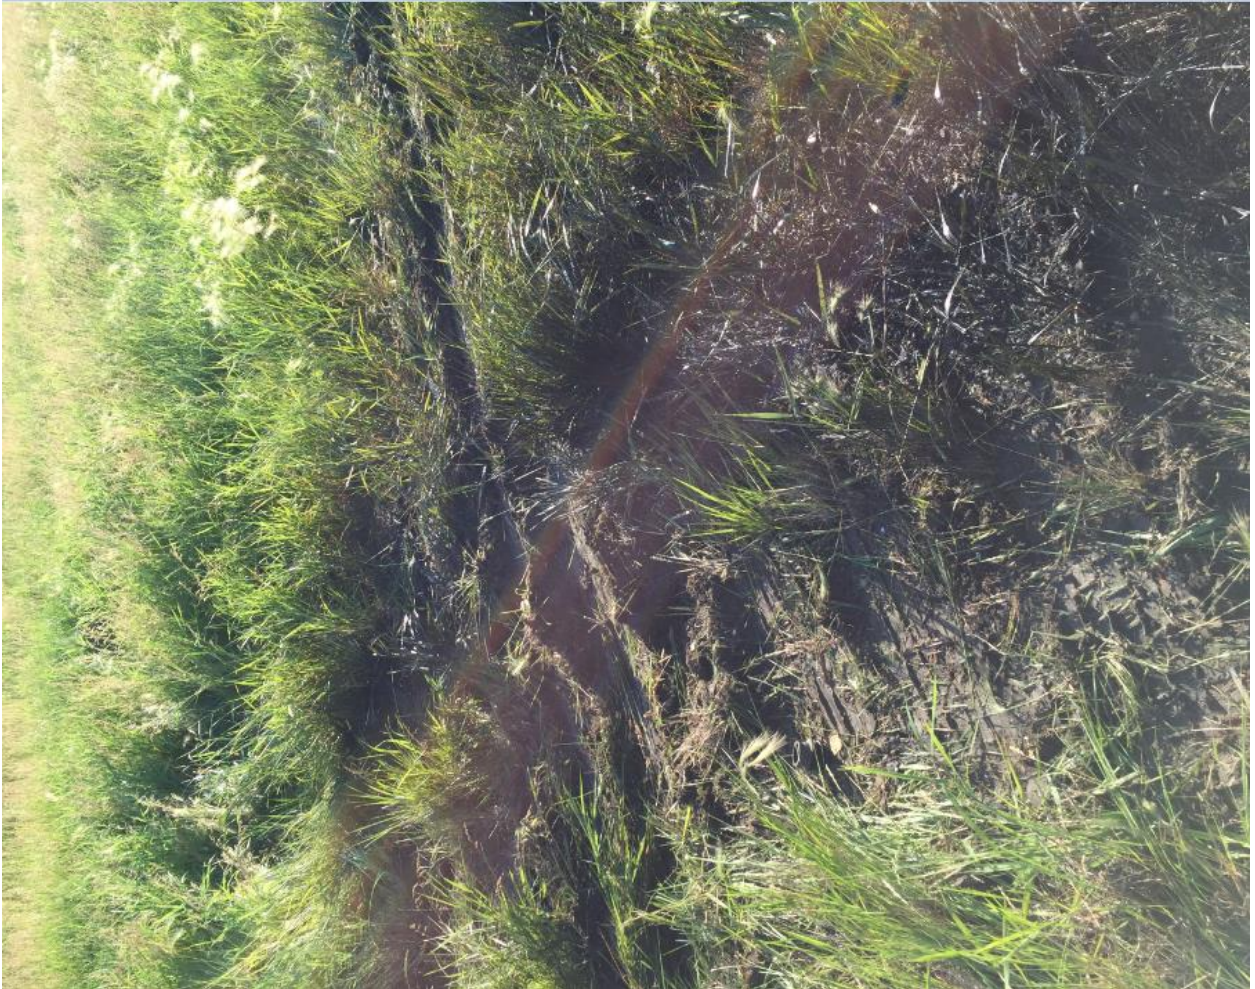
PHOTO #3

DESCRIPTION: Soil with oil/fuel

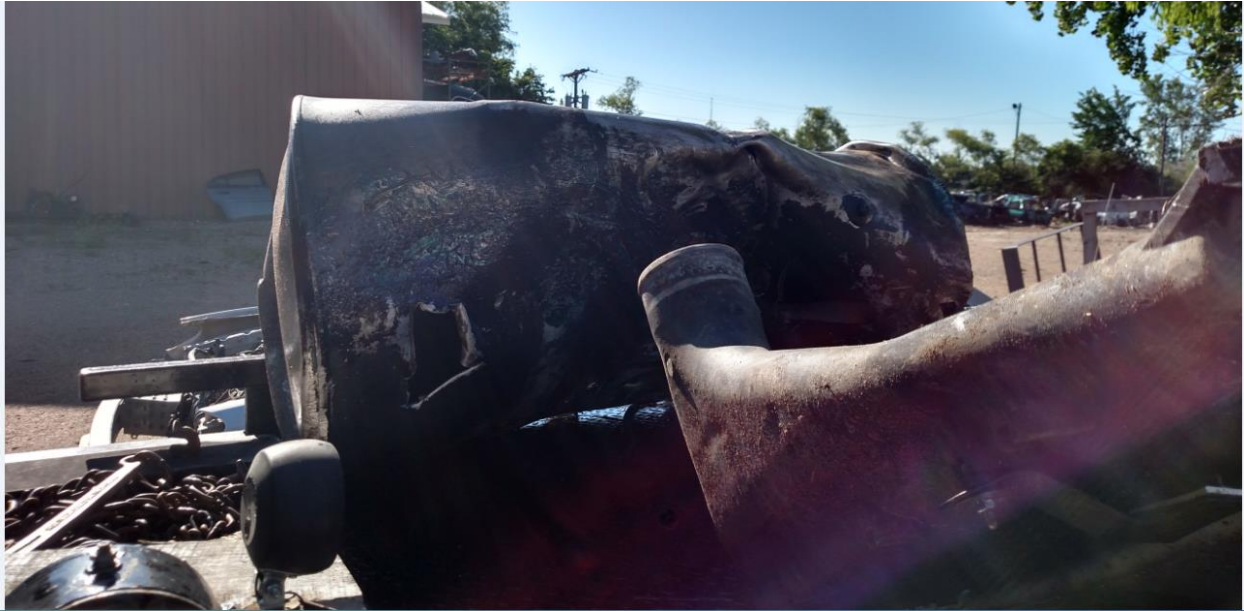
PHOTO #4

DESCRIPTION: Dicks Roll Off #1

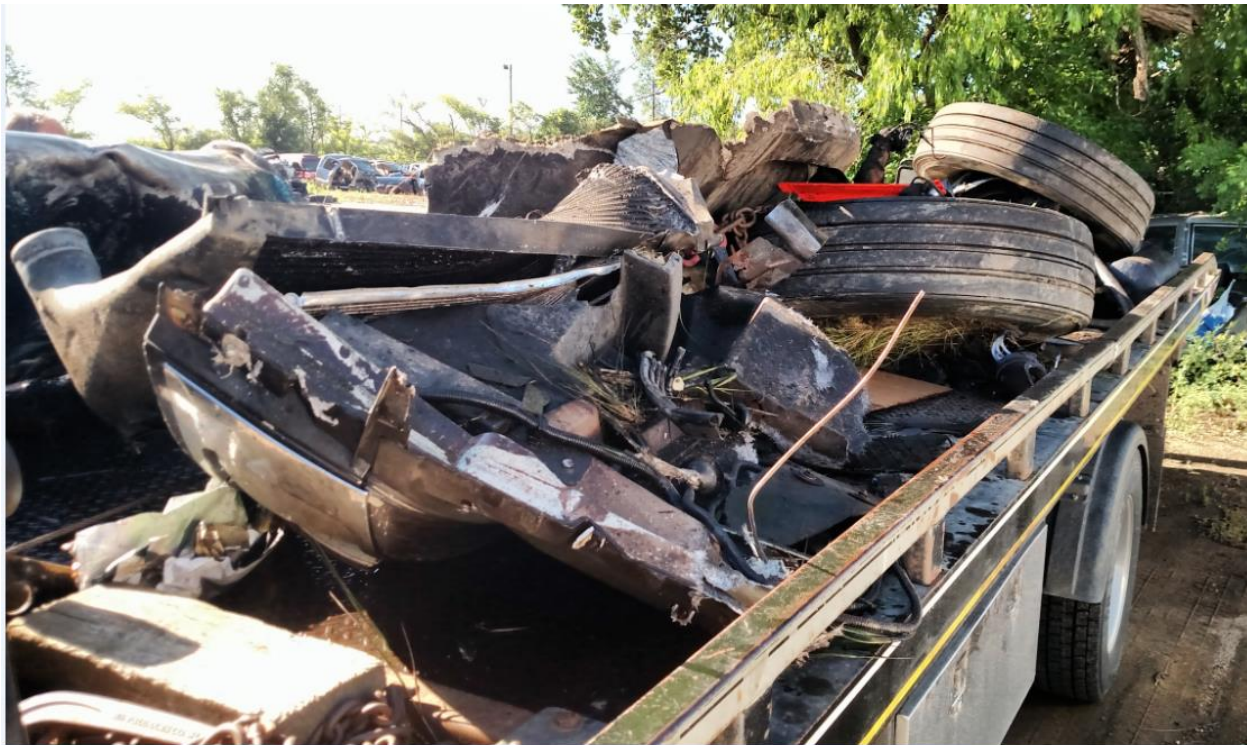
PHOTO #5

DESCRIPTION: Dicks Roll Off #2

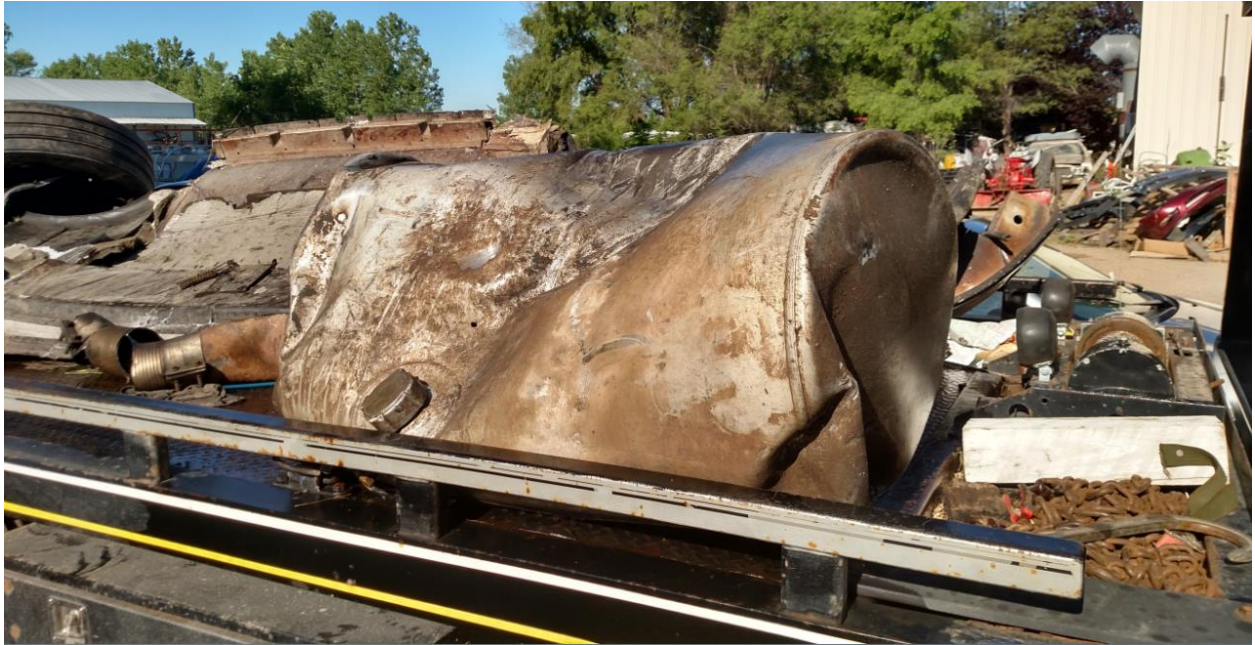
PHOTO #6

DESCRIPTION: Dicks Roll Off #3

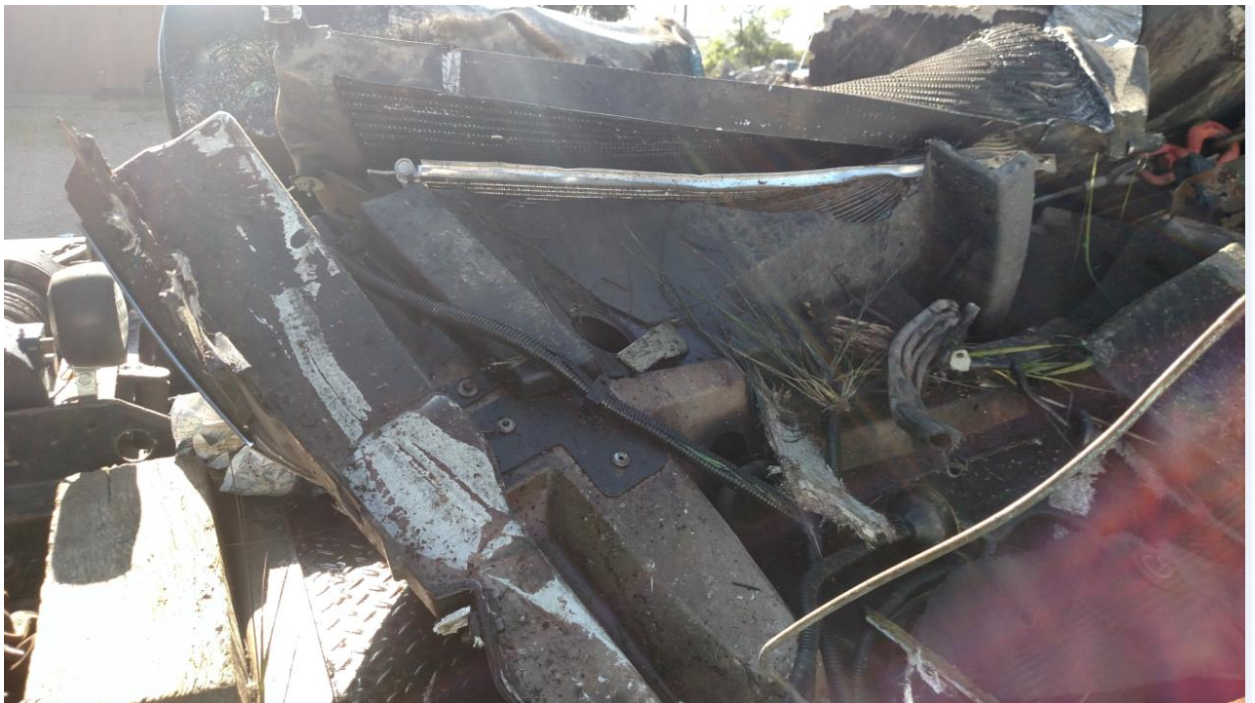
PHOTO #7

DESCRIPTION: Dicks Roll Off #4

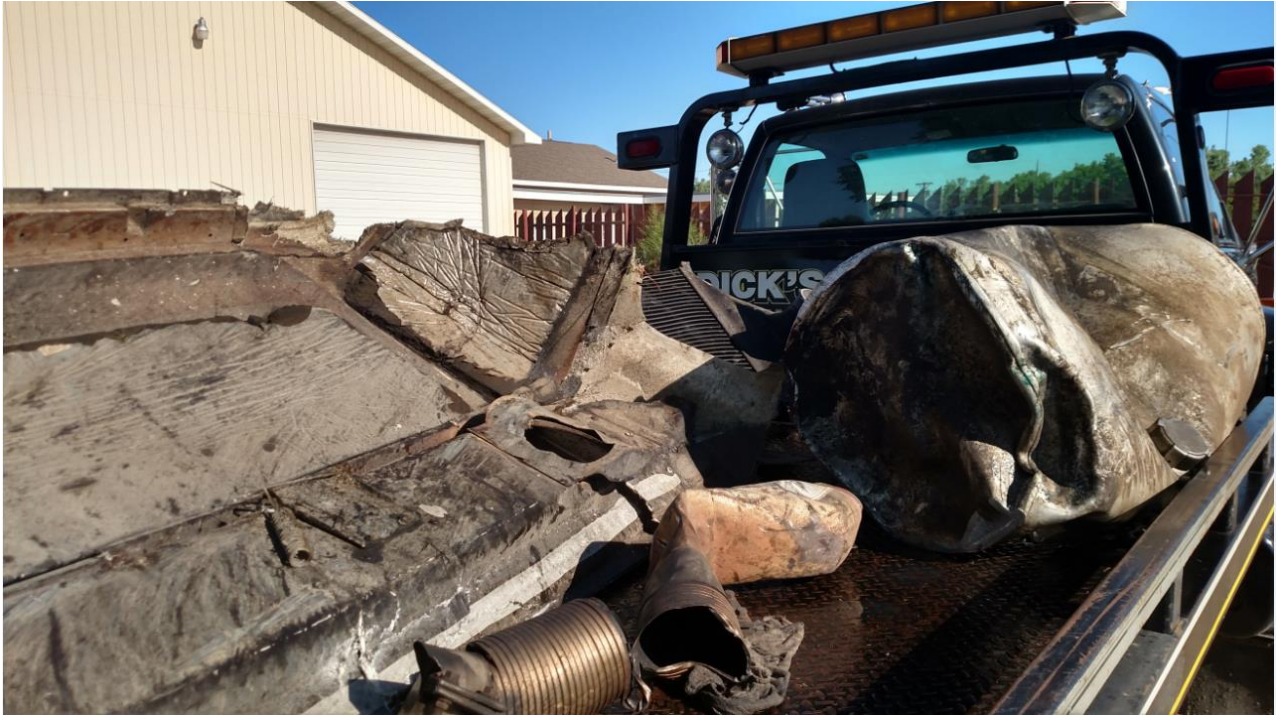
PHOTO #8

DESCRIPTION: Dicks Roll Off #5

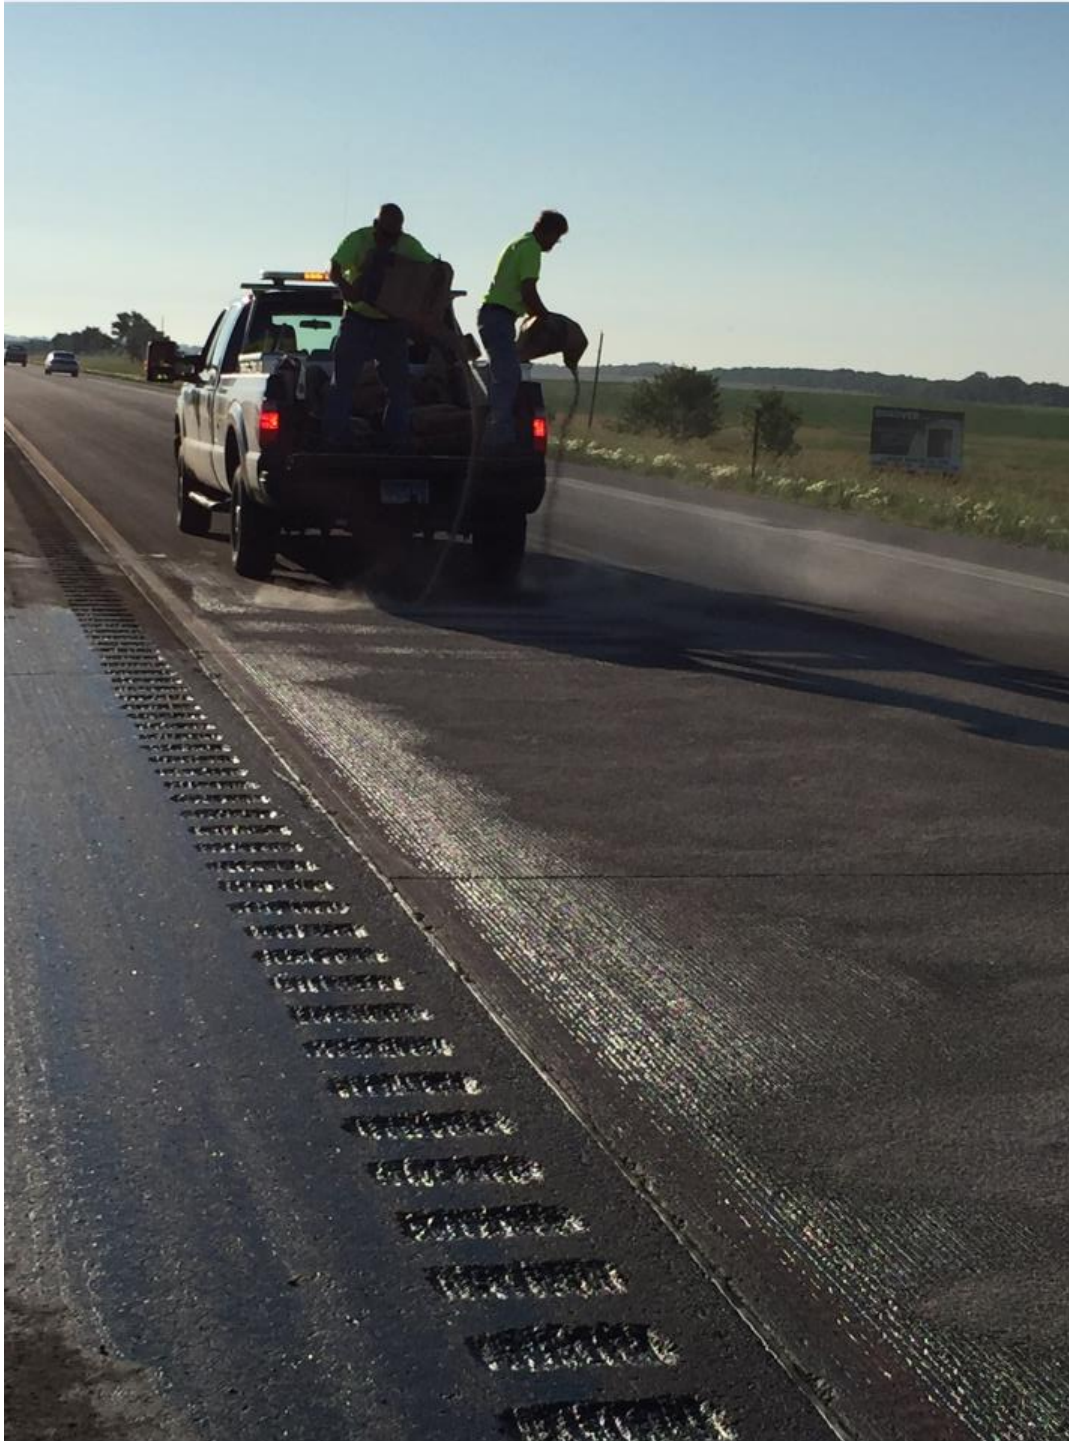
PHOTO #9

DESCRIPTION: DOT Applying Floor Dry-Looking East

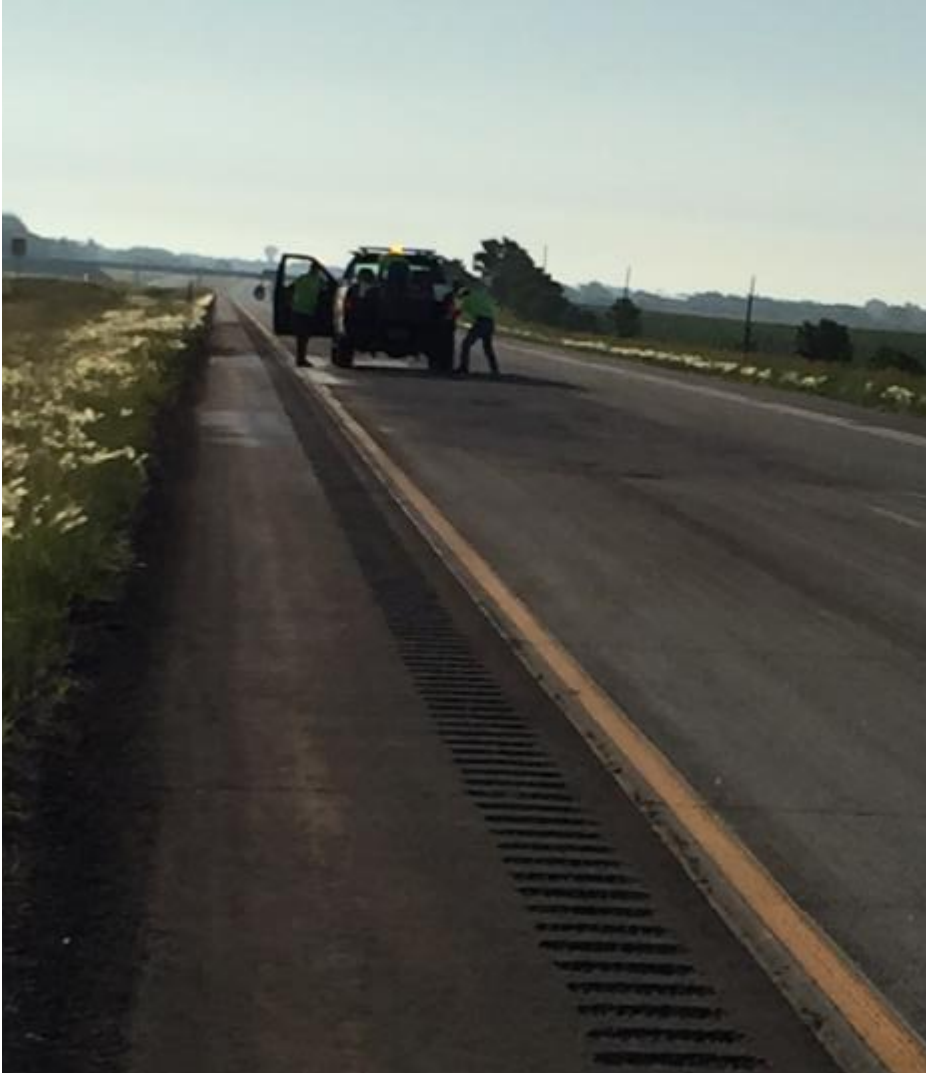
PHOTO #10

DESCRIPTION: DOT Applying Floor Dry-Looking East

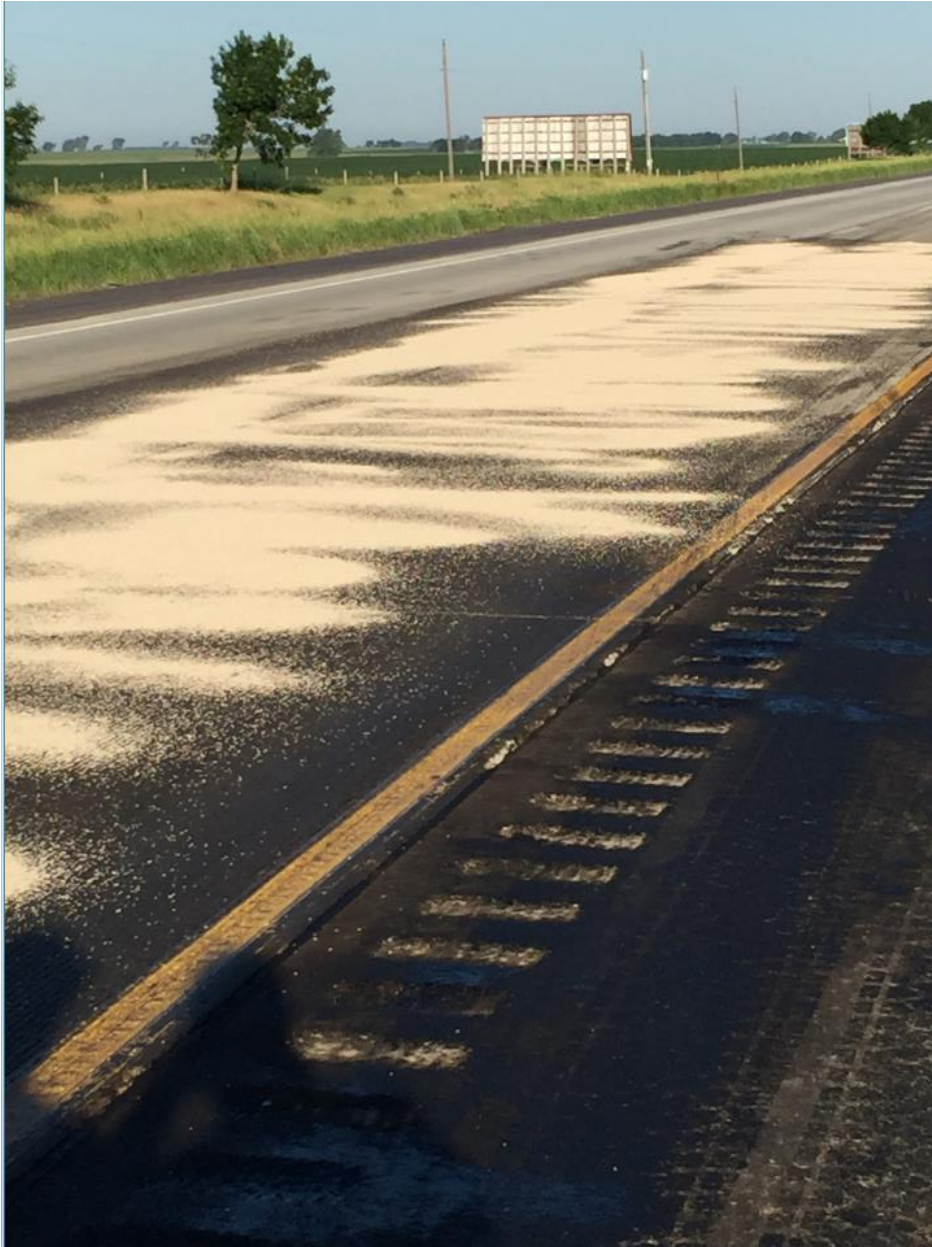
PHOTO #11

DESCRIPTION: Floor Dry-Looking West

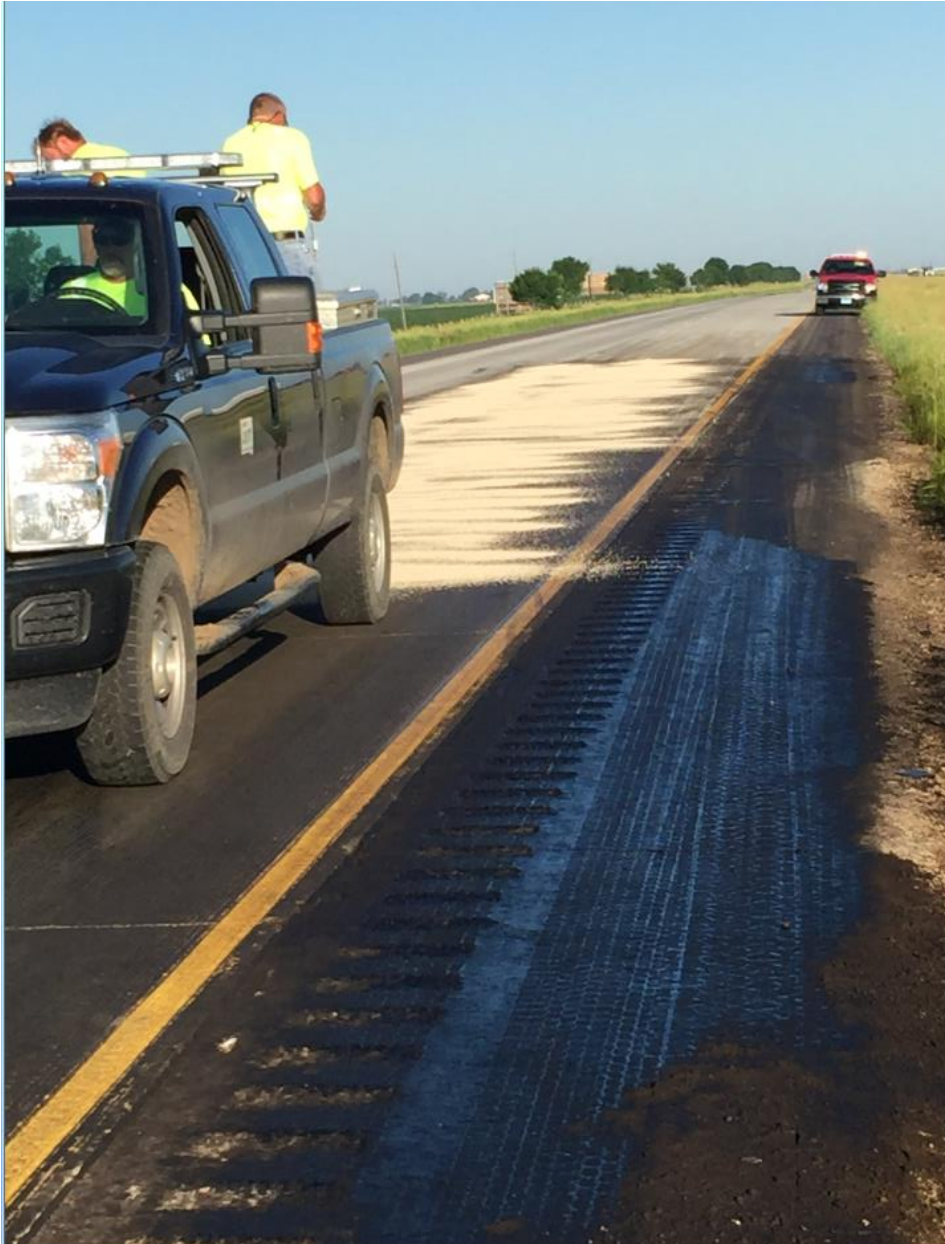
PHOTO #12

DESCRIPTION: Floor Dry2-Looking West

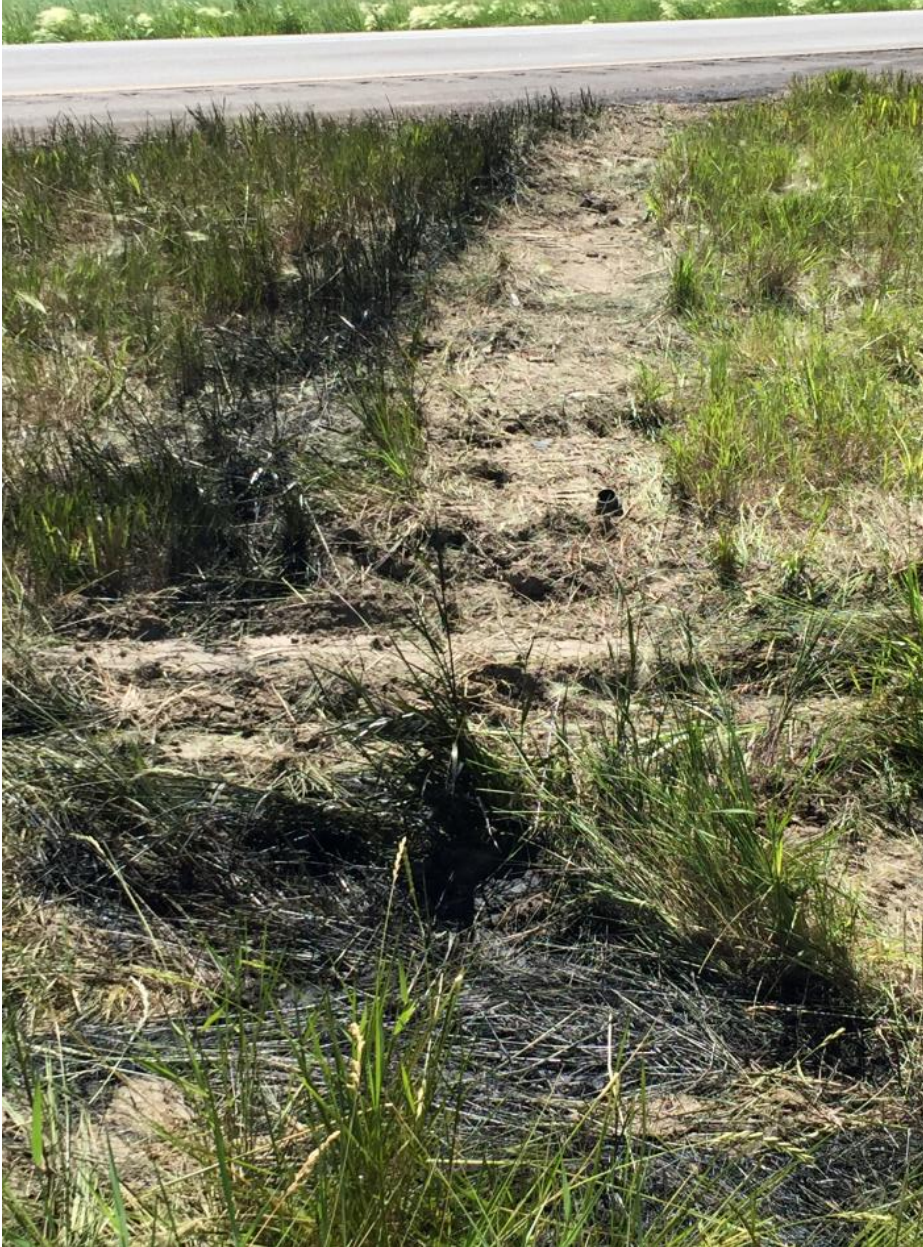
PHOTO #13

DESCRIPTION: Oil in ditch at 1400 on 15 JUN 2016
