Liquid Fertilizer Spill
CHS – Mitchell, SD
Case #16SP102901

On 10-29-2015, at 1:30PM, Bryan Tipton, Program Specialist with the SDDA requested that Sherrie Petersen, AG Inspector, investigate 2700 gallons of 10-34-0, liquid fertilizer, spill that CHS of Mitchell, SD reported at 253rd street and 406th Ave in Davison County.

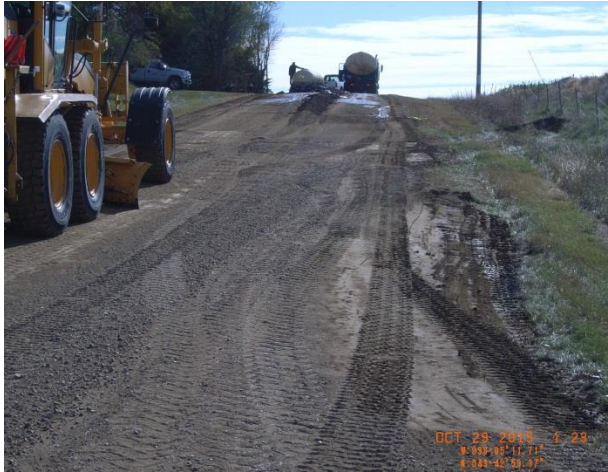
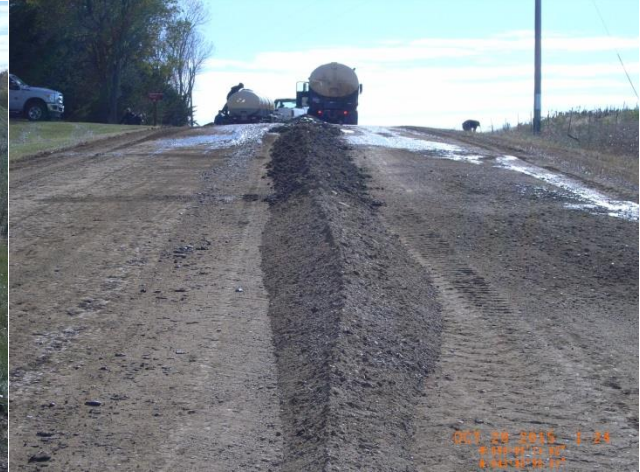
The first picture and second pictures were taken facing south showing where the truck stopped on top of the hill, spilling the 10-34-0, down the hill and into the east and west ditches.

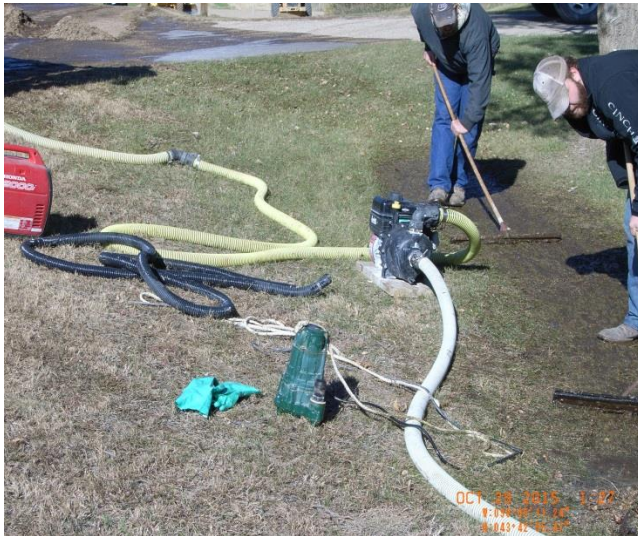
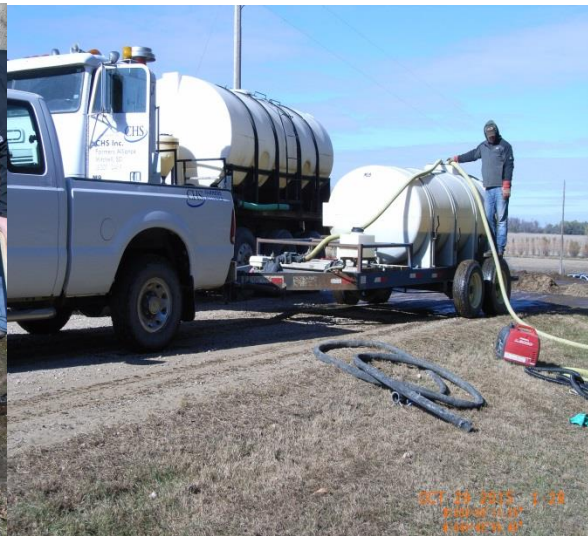
The first picture was taken facing north showing the clean-up process in the east ditch. The second picture shows a small tank, collecting the 10-34-0, approximately 300 gallons of product was recovered.

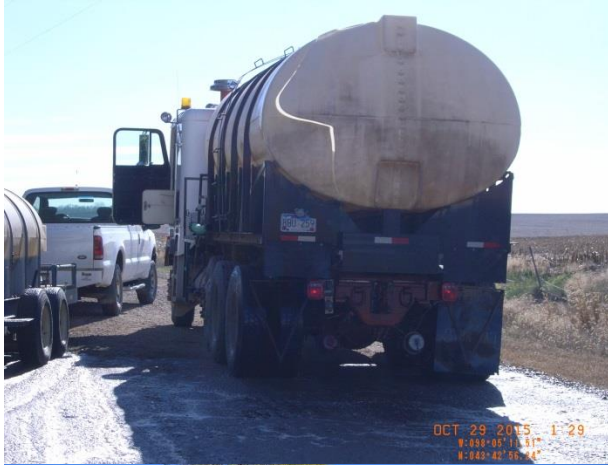
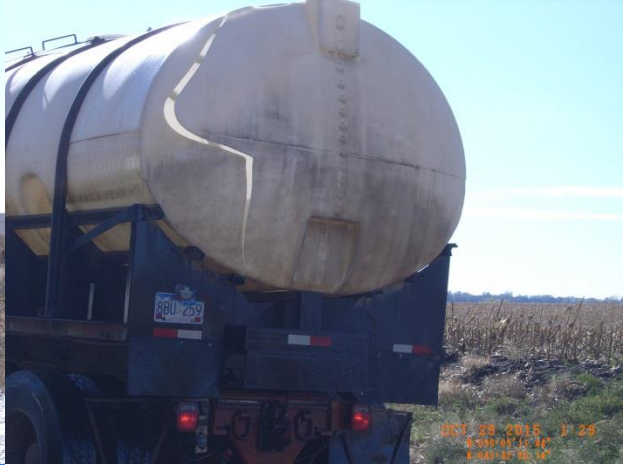
At 2:00PM, Inspector Petersen met with Mr. Morgan. After presenting my credentials and explaining why Inspector Petersen was there a Voluntary Statement (Attachment # 3) was filled out and signed by Mr. Morgan. Mr. Morgan informed Inspector Petersen that Mr. Morgan turned onto 406th Ave, when Mr. Morgan heard a cracking sound coming from the back of the truck, Mr. Morgan looked back and he saw the 10-34-0 spilling out of the tank and unto the gravel road. Mr. Morgan set he brakes on the truck and called Mr. Wilson, for further instruction.

The first two pictures were taken facing south showing the crack in the poly tank where the 10-34-0 leaked out. The third picture was taken facing east, showing the whole truck that was hauling the poly tank in back.

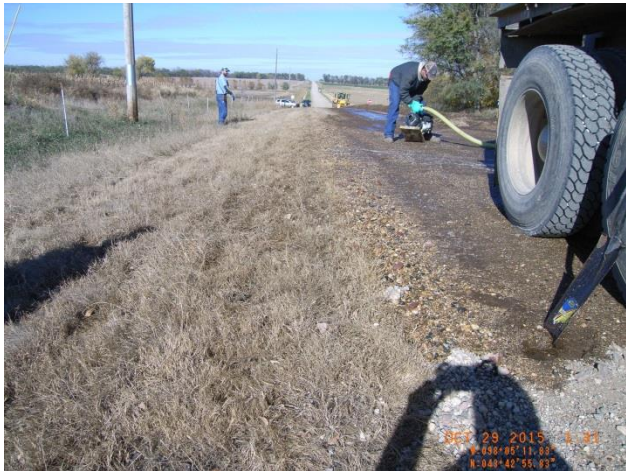
This picture was taken facing north, showing the west ditch.

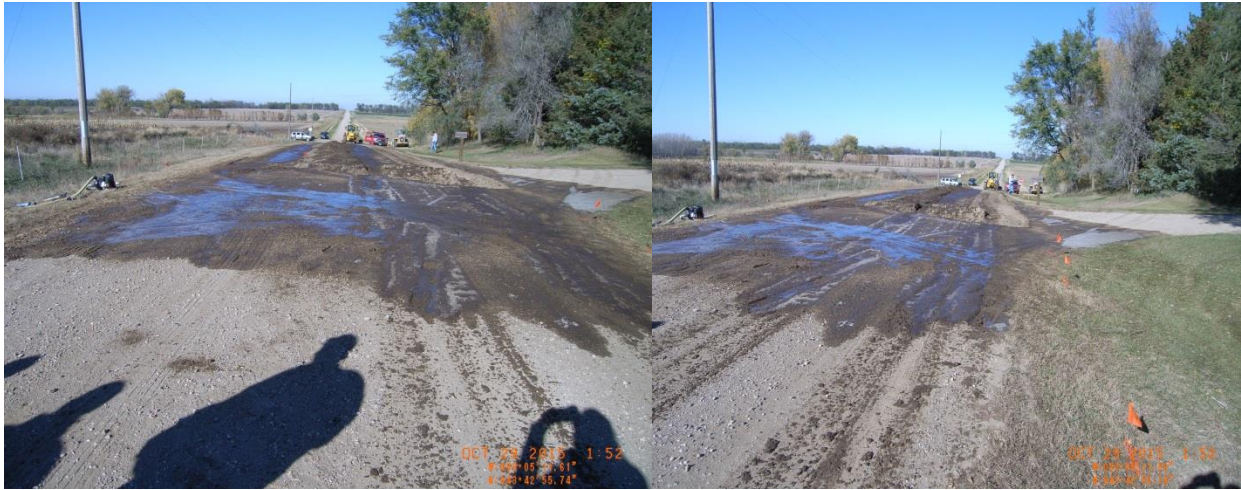
These two pictures were taken facing north. Showing what is left to clean up on the gravel road.

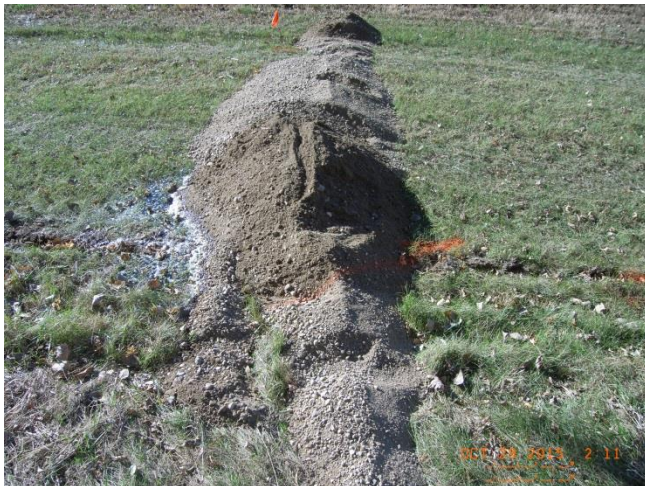
This picture was taken facing west, showing one of the dirt dikes that were built to contain the spill in the east ditch.
